**DEPARTMENT OF TRANSPORTATION**

Contract #: 04-0120F4Cty: SF/ALA Rte: 80 PM: 13.2/13.9File #: 69.28**WELDING INSPECTION REPORT****Resident Engineer:**Siegenthaler, Peter**Address:** 333 Burma Road**City:** Oakland, CA 94607**Report No:** WIR-018371**Date Inspected:** 23-Nov-2010**Project Name:** SAS Superstructure**OSM Arrival Time:** 700**Prime Contractor:** American Bridge/Fluor Enterprises, a JV**OSM Departure Time:** 1900**Contractor:** Zhenhua Port Machinery Company, Ltd (ZPMC), Changxing Island **Location:** Shanghai, China**CWI Name:** Mr.Xu Le Fung.**CWI Present:** Yes No**Inspected CWI report:** Yes No N/A**Rod Oven in Use:** Yes No N/A**Electrode to specification:** Yes No N/A**Weld Procedures Followed:** Yes No N/A**Qualified Welders:** Yes No N/A**Verified Joint Fit-up:** Yes No N/A**Approved Drawings:** Yes No N/A**Approved WPS:** Yes No N/A**Delayed / Cancelled:** Yes No N/A**Bridge No:** 34-0006**Component:** Tower and Orthotropic Box Girder (OBG)**Summary of Items Observed:**

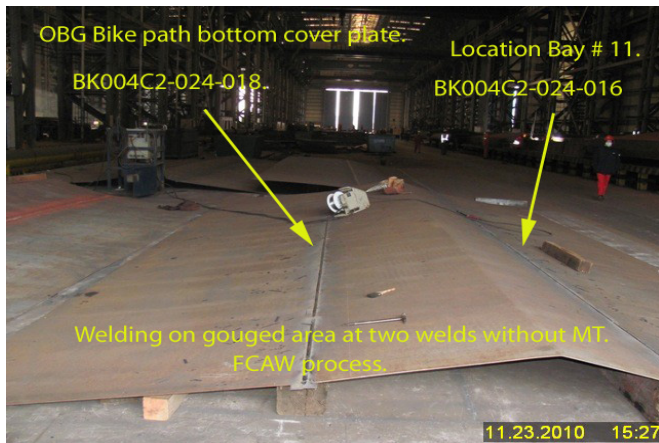
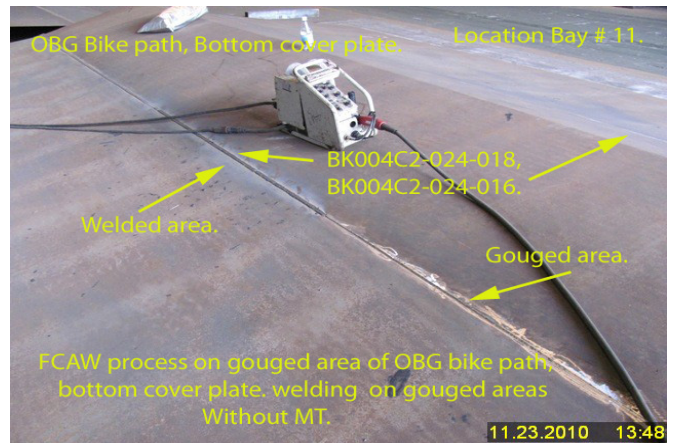
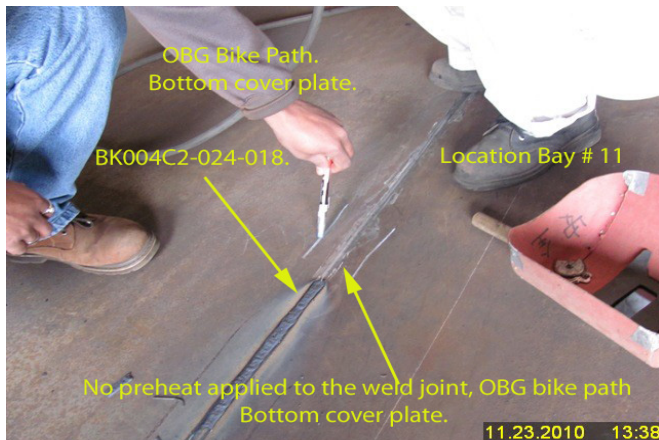
During Caltrans QA in process observations of the fabrication of OBG Bike Path bottom cover plate. This QA discovered the following issue(s): ZPMC welding personnel did not appear to be following the NEW WELD PROCEDURE (Rager / McQuaid) The following requirements were not followed:

The weld is identified as BK004C2-024-018, 016. The welding process used was Flux Core Arc Welding (FCAW).

The area was being not preheated to 165 degrees. ZPMC personnel did not inspect 100% VT and MT of backgouged area before welding began from the second side. The weld is a Completed joint Penetration, (CJP)

joining 6mm plate to 6mm plate. The weld is not SPCM. OBG Bike path, Bottom cover plate is located in Bay # 11. For further information, please see the attached picture below. This QA Inspector generated Incident report on this date.
